Stewardship of West Virginia NHD, 2011-2012

October 2012

This report presents results for West Virginia's current NHD project, "A Policy for Maintaining the NHD in West Virginia's Areas of High Change." As the name suggests, the over-arching goal of the project is to develop a policy and methodology for maintaining West Virginia's high resolution NHD dataset in areas of high change related to urban development, resource extraction, road construction or other factors. The specific goals of the project, as outlined in the statement of work, are as follows:

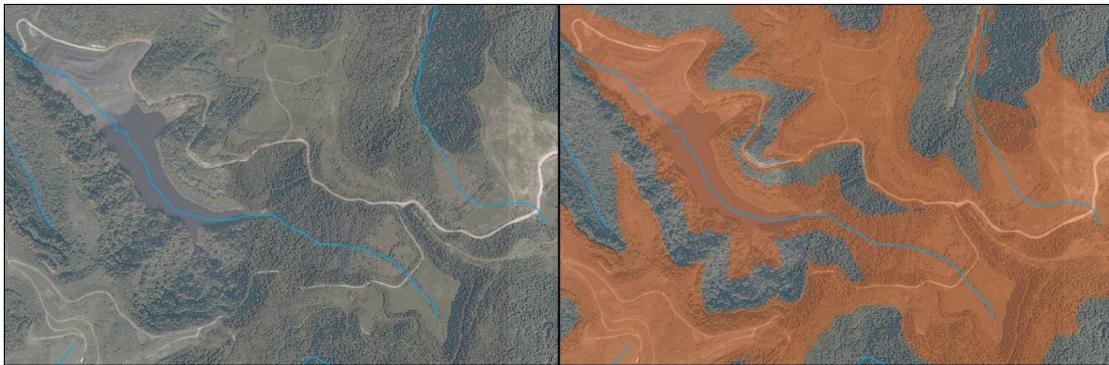
Figure 1. Stream reach affected by mining; in this case, the permit boundary data (orange, right) effectively identifies the damaged reach. The WVDEP fill analysis data (not pictured) also identifies the reach.

Figures 1 and 2 illustrate reaches that needed to be identified and edited due to impacts from surface mining. The main take-away point from these figures is to note that the WVDEP fill analysis data captures impacts that permit boundary data does not. While an exhaustive analysis (and verification data) would be required to account for both errors of commission as well as omission, it appears to be generally true that the WVDEP fill analysis data exhibits a very low degree of errors of commission. Errors of omission when utilizing that dataset appear to be related to the temporal limits of the analysis and to the fact that not all mining includes fills. The same cannot be said for the WVDEP permit data, which exhibits high degrees of errors of both types.

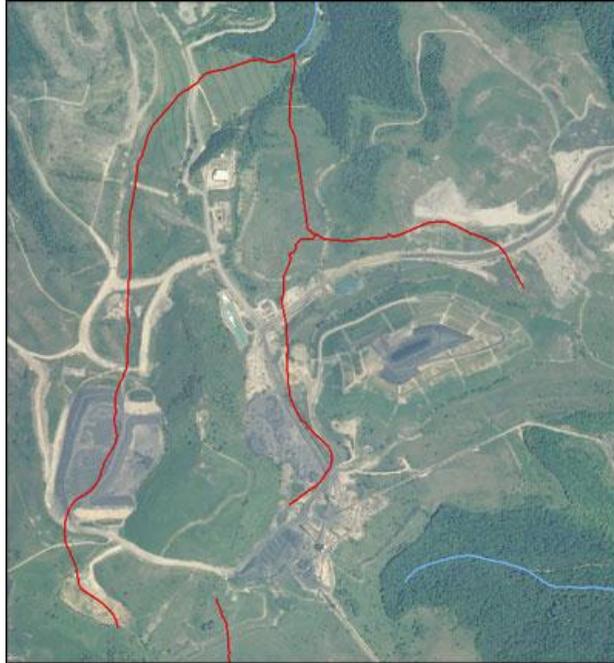
Figure 3. Mined area with effected streams marked (red)

The effected streams in Figure 3 (marked in red; identified in the process described later in this document) all require editing due to mining activity. The question at hand is simple: how, if at all, have these features been “replaced?”

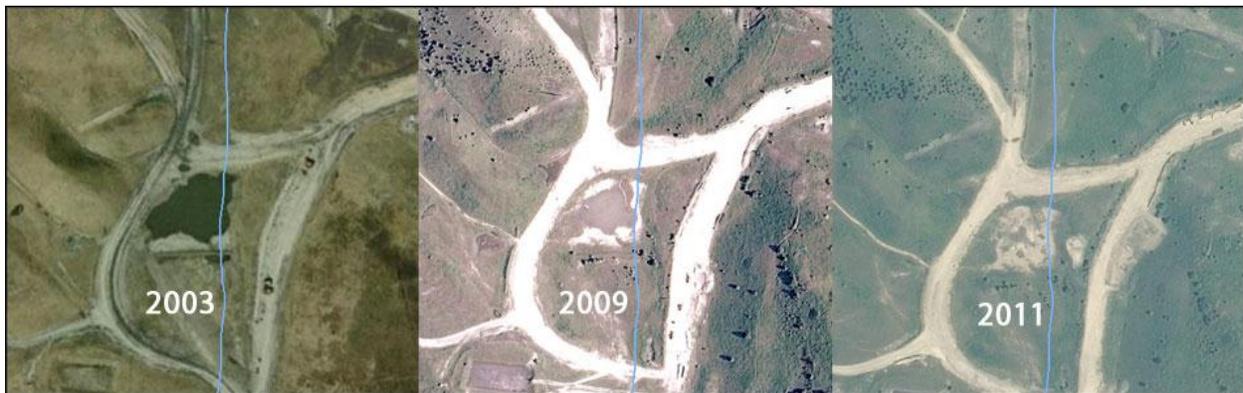
Figure 4. Disappearing 2-d feature

Identifying 2-d features on surface mines is relatively simple. Drainage ponds tend to be fairly sizeable and numerous. Drainage ponds, however, pose a problem: permanence. As you can see in Figure 4, over the course of 8 years, the drainage pond in this example disappears. This example exemplifies a fairly standard problem in mapping drainage patterns in coal mining areas. To some extent, all surface drainage demonstrates a high level of impermanence, but these areas are especially unpredictable. Experience has taught us that these landscapes are subject to accelerated natural

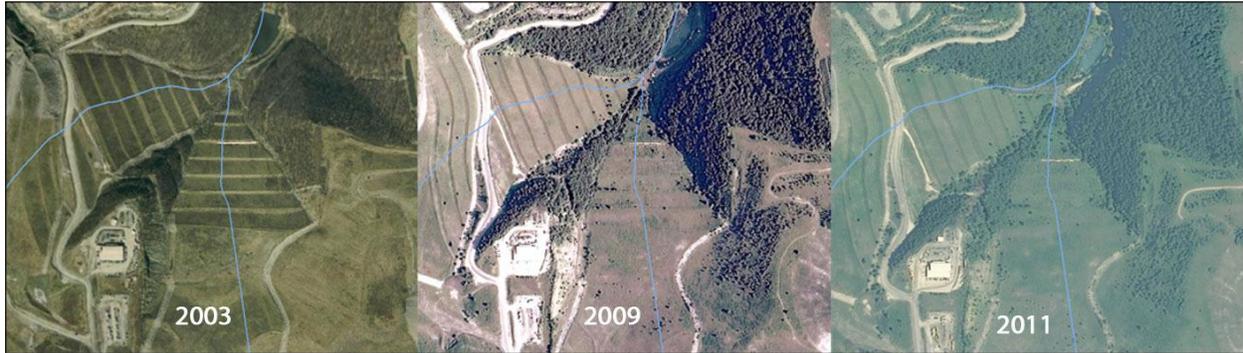
Figure 5. Gravel rip-raps on valley fills.

The one concern with this plan is that the lion's share of imagery available to us in this effort is leaf on. Figure 5 shows the same area over 3 timestamps. The rip raps are only clearly visible in the 2003 image – which happens to be very recently after the fills were constructed. It remains to be seen how viable it is to collect these features in a uniform manner, especially given the lack of availability of leaf-off photography pre-2003.

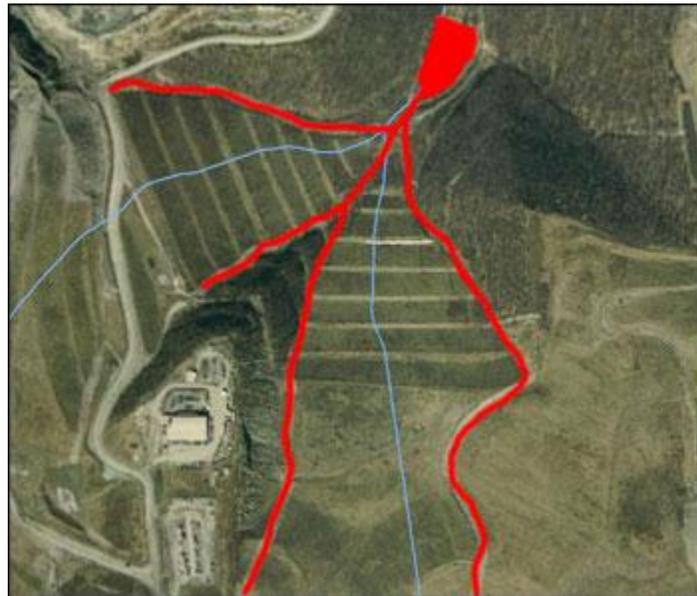
Figure 6. Gravel rip-rap and drainage pond detail.

Some features, however, have a more permanent fixture on the landscape post-mining. The most apparent (and, because of high visibility, the most easily collectible) features on reclaimed surface mines are large gravel ditches. These ditches are always present to some degree on and/or around a valley fill. At the base of the valley fill(s), and at the terminus of the ditches, one can almost always find a drainage pond which then feeds into the remaining portion of the original stream. Figure 5 depicts two valley fills. The gravel rip raps lie on the outer edges of the fills and extend a short distance into the reclaimed surface mine. These features clearly serve a drainage function and because of that, we will endeavor to collect these features and replace HR NHD in those areas with these features. Figure 6 represents a crude representation of these features (red).

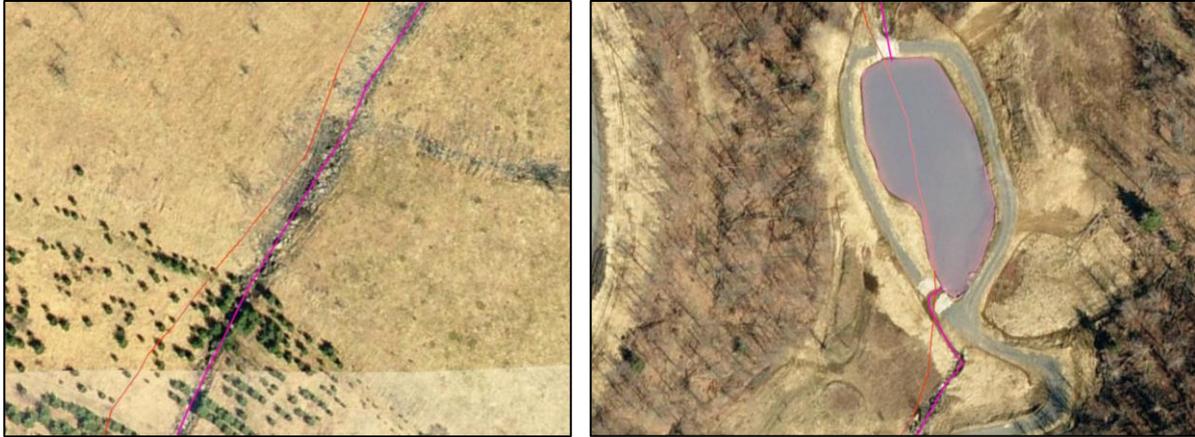
Figure 9. Typical replacement features in post-surface mining areas; linear feature (left), lake/pond feature (right).

Prior to editing, we consulted with the USGS in order to determine the appropriate feature type values for each of these feature. At USGS' recommendation, we utilized the Canal/Ditch FTYPE for all features similar to those depicted in Figure 9 (left) and Lake/Pond for now ponds (Figure 9, right). Using photo interpretation, we were able to subjectively determine the extent to which a stream was replaced by a ditch.
